**Flood Control Project Maintenance
Levee Inspections**
LMA District Cover Sheet
Spring 2016 Levee Inspection Results

American River Flood Control District

Spring 2016 Levee Inspection Results

Waterway			Bank	Unit Miles
Unit No. 01 Arcade Creek			Left	2.08
	Spring (March - May)	Summer (June - August)	(September - November) Fall	Winter (December - February)
Unit Maintenance Rating (Fall Only)				
Date of Inspection	3/2/2016 - 3/2/2016			
DWR Inspector	Maksim Khashchuk			
Accompanied By	Richard Marck ARFCD			
	Sterling York

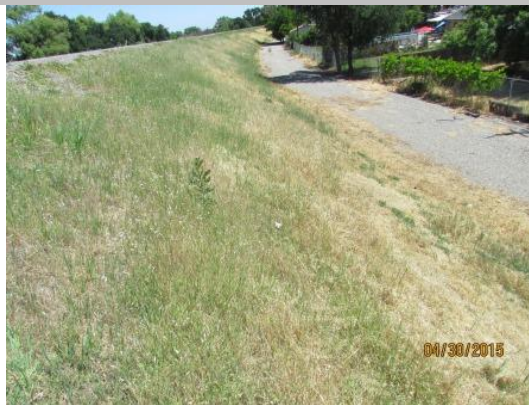
Photo 2 of 2 : SP_2016_NA0001_51_164_20160229_00040.jpg

Another view of the depression on the landside levee slope.

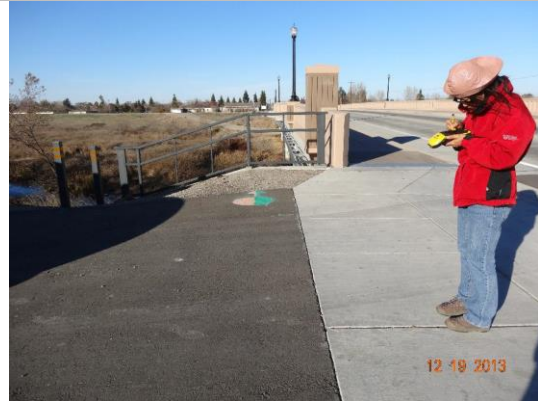
Photo 1 of 1 : UCIP_SP_2016_31169_57044.jpg

LM Start	0.66	Rating **	M	Issue No.	188
LM End	0.66	Issue Type +	En	Location *	LS
Category	Supplemental			GPS Latitude/Longitude	
				Start	End
Item	DWR UCIP Field Study			38.623668 °	38.623668 °
				-121.457156 °	-121.457156 °
DWR ID					
Comment Code					
Inspector Comment					
FS_ID:31169 DS_ID:24800 EP_NO: N/A Repair Type: Non-Urgent Crossing Status: Found UCIP Comments: Need to coordinate with the City of Sacramento to determine if structure (assumed indicated by green/orange symbol) crosses levee or symbol is referencing bridge. FIELD_STRUCT_DESC: Indicator of crossing found on waterward side edge. Symbol for Flood Control Structure (green/orange circle) was found during field inspection 12/19/13, symbol matches flood control structures that the City of Sacramento inspects. FS Date: 12/19/2013

Indicator of crossing found on waterward side edge. Symbol is a Flood Control Structure (green/orange circle).

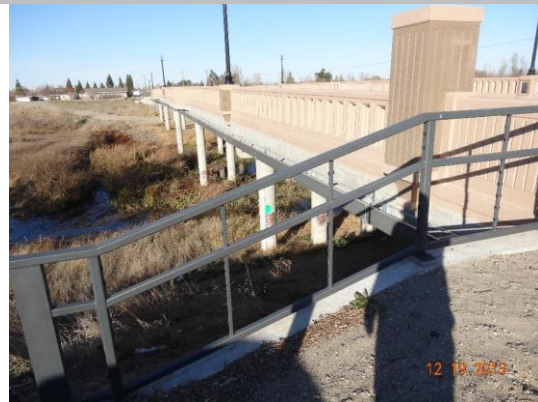
Photo 1 of 2 : UCIP_SP_2016_31167_57042.jpg

LM Start	0.66	Rating **	U	Issue No.	187
LM End	0.66	Issue Type +	En	Location *	LS
Category	Supplemental			GPS Latitude/Longitude	
				Start	End
Item	DWR UCIP Field Study			38.623667 °	38.623667 °
				-121.457134 °	-121.457134 °
DWR ID					
Comment Code					
Inspector Comment					
FS_ID:31167 DS_ID:24266 EP_NO: 3417 Repair Type: Urgent Crossing Status: Found UCIP Comments: no markers visible on waterward or landward side indicating this is a gas line--need to contact owner to determine if this crossing is gas line. FIELD_STRUCT_DESC: 4-inch steel gas line through the levee, 1.5 feet below the crown. Corrugated metal (CM) cutoff wall around pipe at center of levee. Pump hung on bridge for channel crossing. (Permit No. 3417-1961) FS Date: 12/19/2013

View of waterward side--pipe suspended along downstream face of bridge.

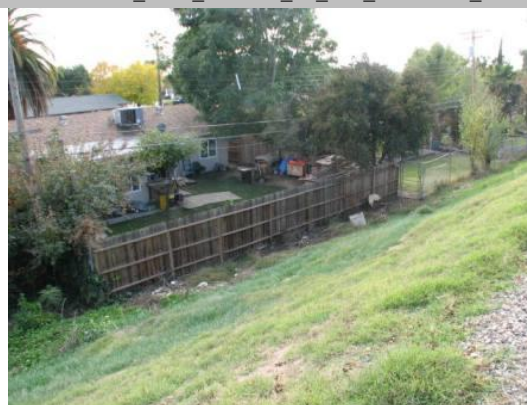
Photo 1 of 1 : SP_2016_NA0001_51_183_20160229_00051.jpg

11/17/2011 Wooden privacy fence.

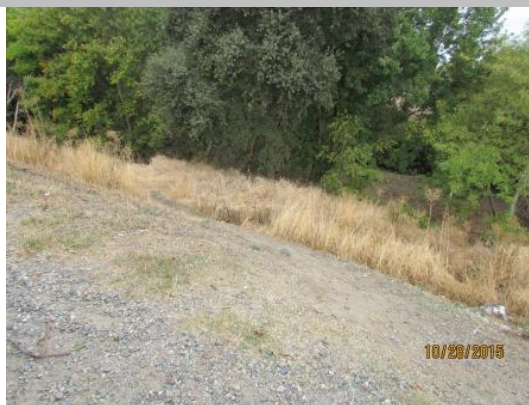
Photo 1 of 1 : SP_2016_NA0001_51_76_20160229_00037.jpg

LM Start	1.05	Rating **	M	Issue No.	76
LM End	1.05	Issue Type +	Ma	Location *	WS
Category	Earthen Levee			GPS Latitude/Longitude	
				Start	End
Item	Slope Stability			38.625069 °	38.625069 °
				-121.450360 °	-121.450360 °
DWR ID	DWR_NA0001_01_f_2015_76				
Comment Code					
S2 : Repair the levee slope damaged by foot traffic and prevent access where possible.					
Inspector Comment

View of the waterside levee slope damaged by foot traffic.

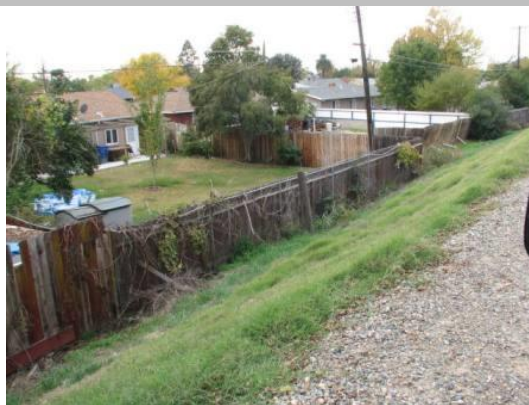
Photo 1 of 1 : SP_2016_NA0001_51_23_20160229_00020.jpg

LM Start	1.14	Rating **	U	Issue No.	23
LM End	1.14	Issue Type +	En	Location *	LS
Category	Earthen Levee			GPS Latitude/Longitude	
				Start	End
Item	Encroachments			38.624869 °	38.624869 °
				-121.448662 °	-121.448662 °
DWR ID	DWR_NA0001_01_s_2012_23				
Comment Code					
FE : Fence					
Inspector Comment					
Dog-eared wooden fence and chain link fence is built against the levee slope.

11/17/2011 Fence built on the levee slope.

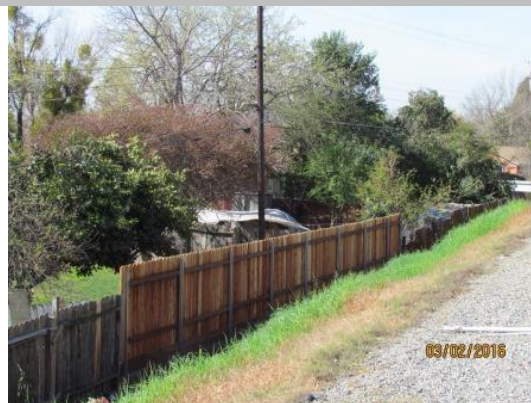
Photo 1 of 1 : SP_2016_NA0001_51_21_20160308_00088.jpg

View of the fence at the landside levee toe.

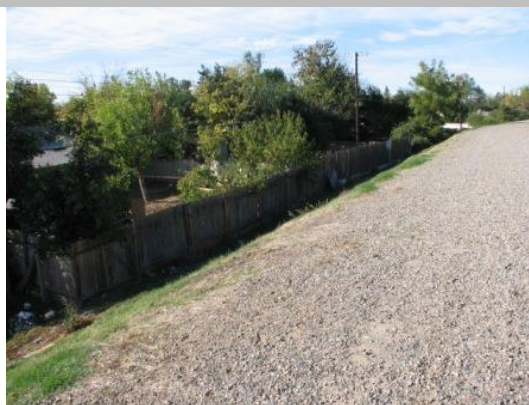
Photo 1 of 1 : SP_2016_NA0001_51_20_20160229_00017.jpg

Photo of solid fences built against the levee slope.

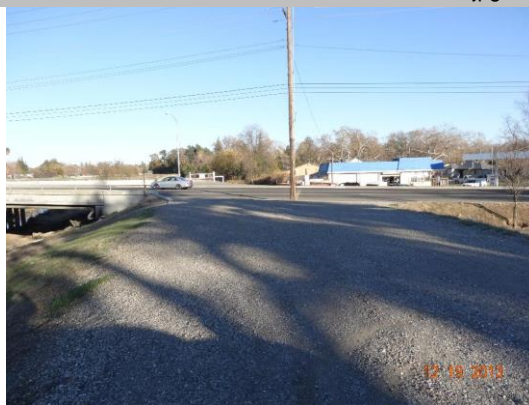
Photo 1 of 2 : UCIP_SP_2016_30085_55489.jpg

LM Start	1.28	Rating **	M	Issue No.	184
LM End	1.28	Issue Type +	En	Location *	LS
Category	Supplemental			GPS Latitude/Longitude	
				Start	End
Item	DWR UCIP Field Study			38.625500 °	38.625500 °
				-121.446390 °	-121.446390 °
DWR ID					
Comment Code					
Inspector Comment					
FS_ID:30085 DS_ID:24576 EP_NO: N/A Repair Type: Non-Urgent Crossing Status: Indicator Found UCIP Comments: Unable to confirm location--will need to coordinate with owner to determine if crossing is still active and determine location. FIELD_STRUCT_DESC: 1 of 3: 16-inch pipe through the levee, 8.0 feet below the crown. Floodgates within the levee across the channel, installed under Permit No. 14480 (1986). FS Date: 12/19/2013

Overview of levee crown at crossing.

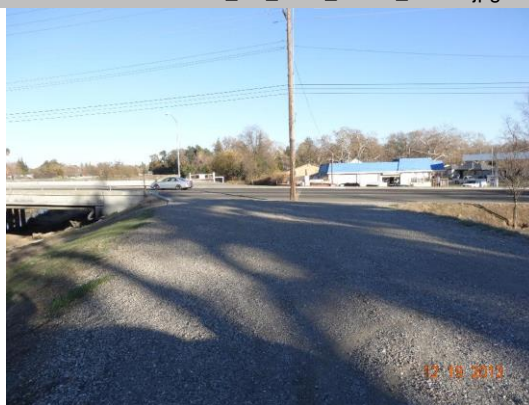
Photo 1 of 2 : UCIP_SP_2016_29732_54976.jpg

LM Start	1.28	Rating **	M	Issue No.	185
LM End	1.28	Issue Type +	En	Location *	LS
Category	Supplemental			GPS Latitude/Longitude	
				Start	End
Item	DWR UCIP Field Study			38.625500 °	38.625500 °
				-121.446390 °	-121.446390 °
DWR ID					
Comment Code					
Inspector Comment					
FS_ID:29732					
DS_ID:24577					
EP_NO: N/A					
Repair Type: Non-Urgent					
Crossing Status: Indicator Found					
UCIP Comments: Unable to confirm location--will need to coordinate with owner to determine if crossing is still active and determine location.					
FIELD_STRUCT_DESC: 2 of 3: 6-inch pipe through the levee, 8.0 feet below the crown. Flap gate on the waterside (WS) end. Floodgates within the levee across the channel, installed under Permit No. 14480 (1986).					
FS Date: 12/19/2013

Overview of levee crown.

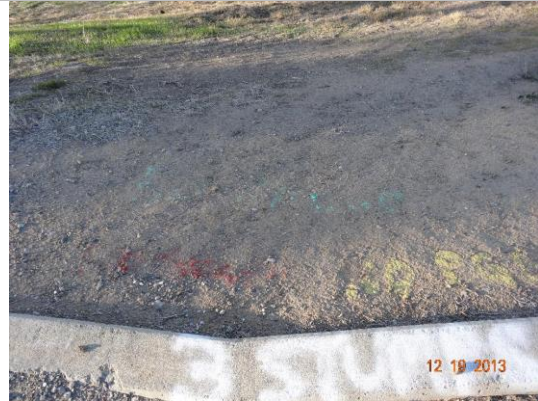
Photo 2 of 2 : UCIP_SP_2016_29732_54975.jpg

LM Start	1.28	Rating **	M	Issue No.	185 (cont)	
LM End	1.28	Issue Type +	En	Location *	LS	
Category	Supplemental			GPS Latitude/Longitude		
				Start	End	
Item	DWR UCIP Field Study			38.625500 °	38.625500 °	
				-121.446390 °	-121.446390 °	
DWR ID						
Comment Code						
Inspector Comment						
FS_ID:29732						
DS_ID:24577						
EP_NO: N/A						
Repair Type: Non-Urgent						
Crossing Status: Indicator Found						
UCIP Comments: Unable to confirm location--will need to coordinate with owner to determine if crossing is still active and determine location.						
FIELD_STRUCT_DESC: 2 of 3: 6-inch pipe through the levee, 8.0 feet below the crown. Flap gate on the waterside (WS) end. Floodgates within the levee across the channel, installed under Permit No. 14480 (1986).						
FS Date: 12/19/2013

Underground service alert (USA) paint markers visible on waterward shoulder--unable to confirm type of crossings.

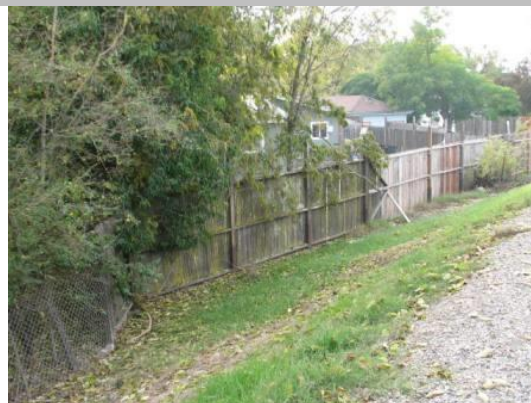
Photo 1 of 1 : SP_2016_NA0001_51_12_20160229_00010.jpg

11/17/2011 Wooden privacy fence built within 15' of the levee toe.

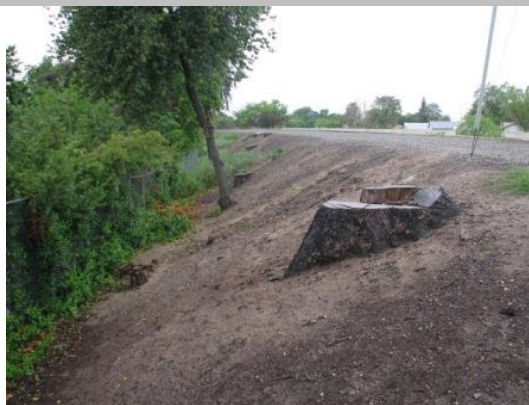
Photo 1 of 1 : SP_2016_NA0001_51_56_20160229_00034.jpg

Several large stumps on levee slope.

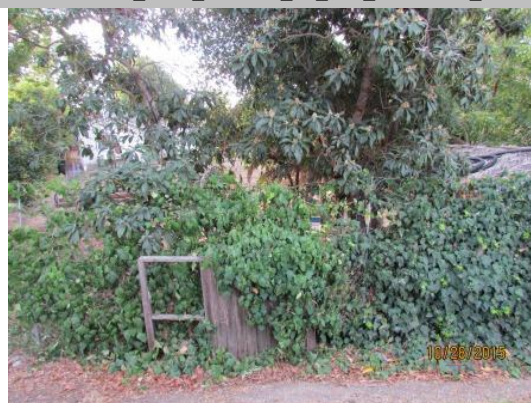
Photo 1 of 1 : SP_2016_NA0001_51_170_20160229_00045.jpg

View of the landscaping at the landside levee toe.

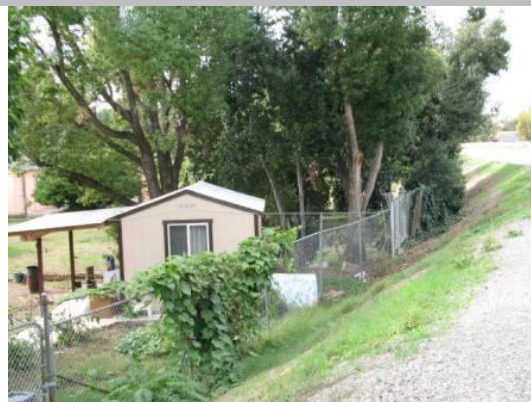
Photo 1 of 1 : SP_2016_NA0001_51_169_20160229_00044.jpg

11/17/2011 Wooden shed on concrete pad built within 15' of levee toe.

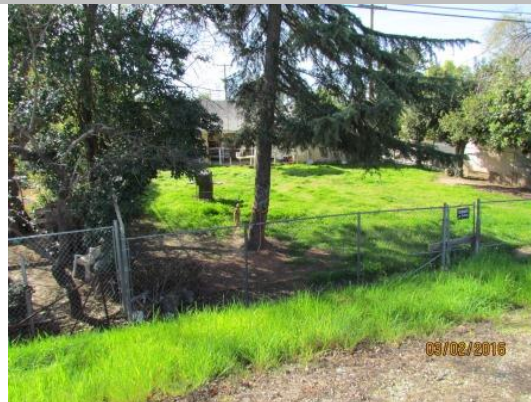
Photo 1 of 1 : SP_2016_NA0001_51_63_20160308_00085.jpg

View of the fence at the landside levee toe.

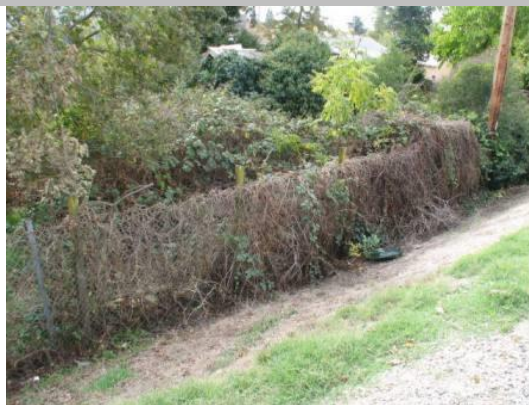
Photo 1 of 1 : SP_2016_NA0001_51_7_20160229_00006.jpg

11/17/2011 Blackberries growing on fence are obstructive.

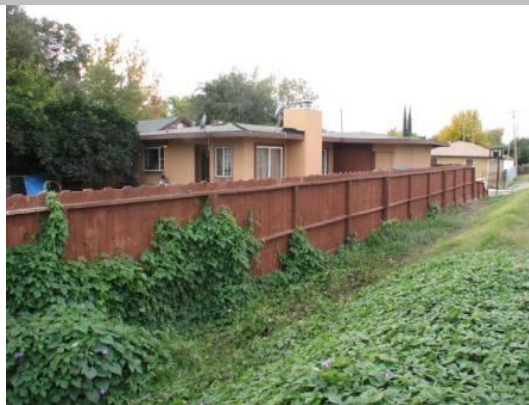
Photo 1 of 1 : SP_2016_NA0001_51_167_20160229_00041.jpg

11/17/2011 Wooden privacy fence built at the levee toe.

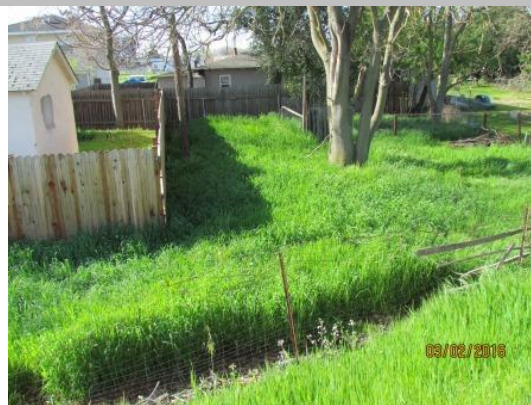
Photo 1 of 1 : SP_2016_NA0001_51_51_20160308_00080.jpg

View of the fence at the landside levee toe.

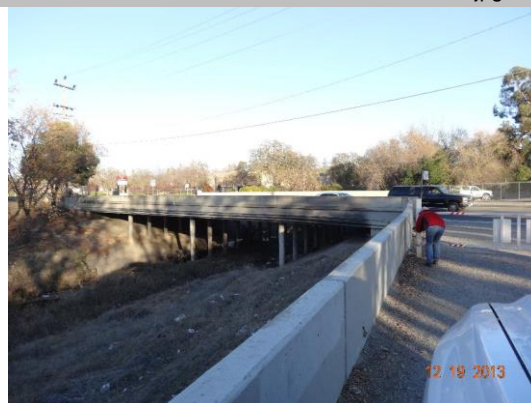
Photo 1 of 2 : UCIP_SP_2016_31185_57091.jpg

Overview markers located on bridge and floodwall indicating crossing through levee.

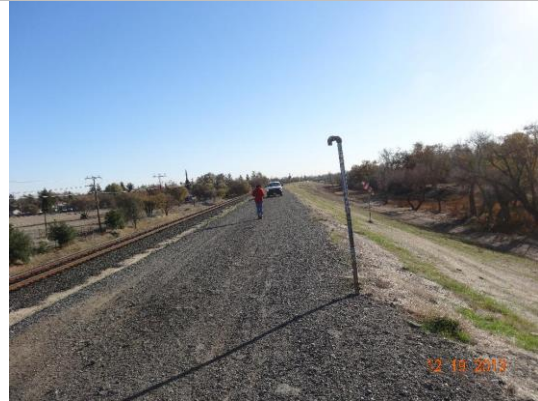
Photo 1 of 2 : UCIP_SP_2016_42132_55451.jpg

Overview of levee crown with utility gas markers on waterward side.

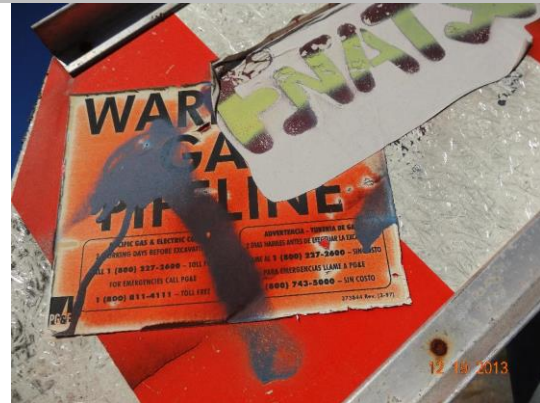
Photo 2 of 2 : UCIP_SP_2016_42132_55453.jpg

Contact information for owner--sign visible on waterward side slope.

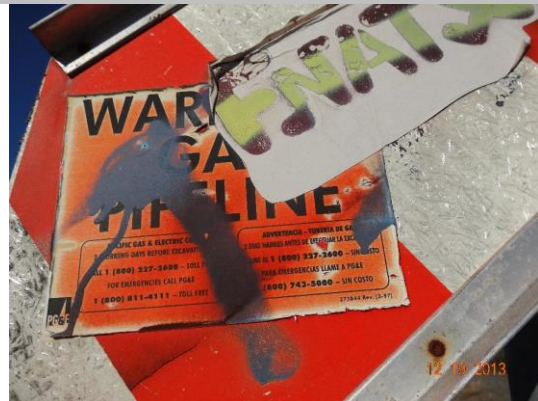
Photo 2 of 2 : UCIP_SP_2016_42130_52768.jpg

Marker with emergency contact information located on waterward slope.

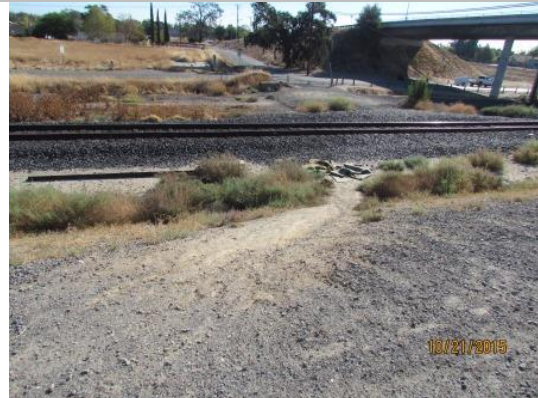
Photo 1 of 1 : SP_2016_NA0001_52_25_20160229_00004.jpg

View of the landside levee slope damaged by foot traffic.

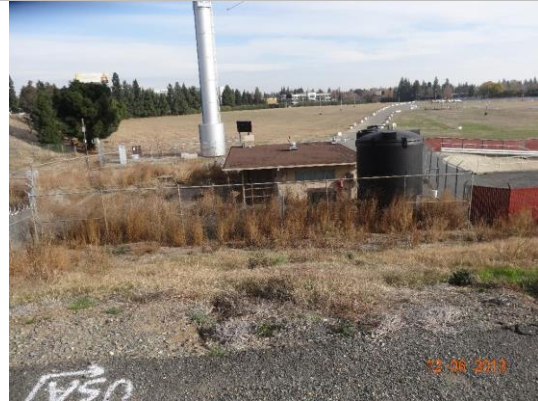
Photo 2 of 2 : UCIP_SP_2016_31227_57138.jpg

View of landward side.

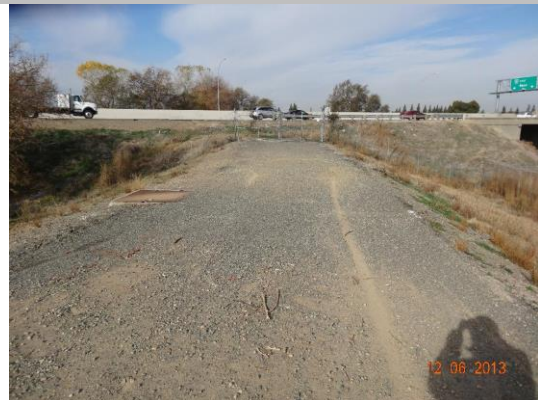
Photo 1 of 2 : UCIP_SP_2016_31223_57124.jpg

View of levee crown and concrete box located on waterward shoulder.

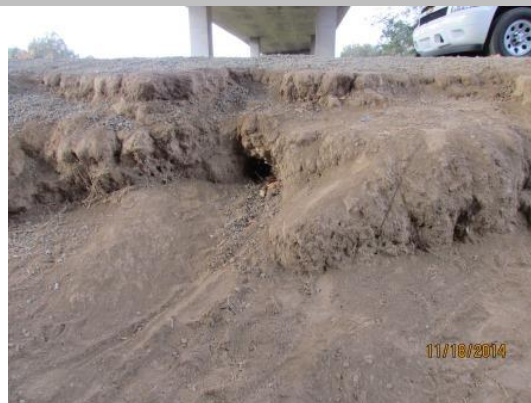
Photo 1 of 1 : SP_2016_NA0001_490_1_20160229_00001.jpg

View of the rodent holes on the landside levee slope.

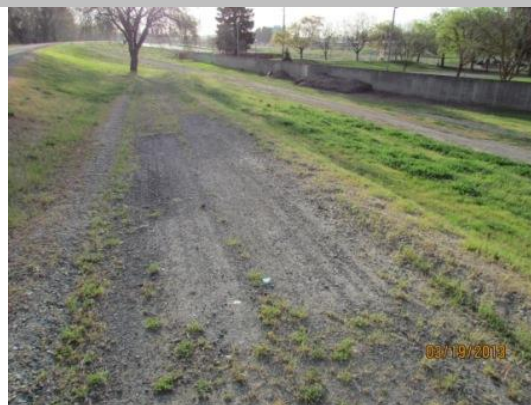
Photo 1 of 1 : SP_2016_NA0001_55_67_20160229_00053.jpg

View of improperly graded bicycle ramp.

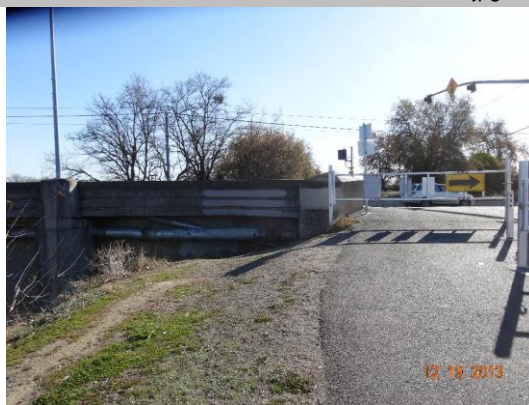
Photo 1 of 2 : UCIP_SP_2016_29027_53496.jpg

View of line exposed at the bridge.

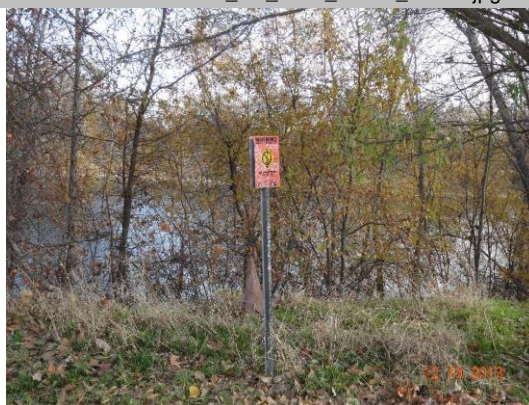
Photo 2 of 2 : UCIP_SP_2016_29927_55261.jpg

Marker for buried fiber optic cable on waterward side.

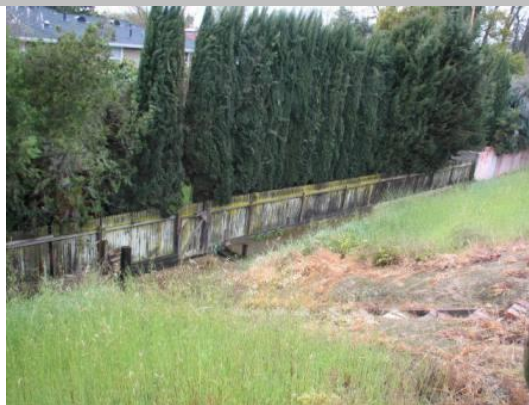
Photo 1 of 1 : SP_2016_NA0001_55_14_20160229_00015.jpg

03/16/2012 Wood privacy fence completely obstructs access and visibility.

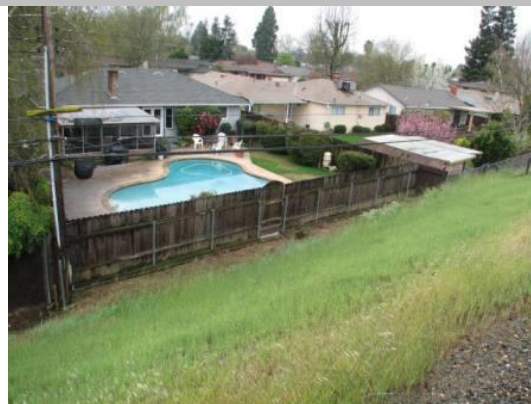
Photo 1 of 1 : SP_2016_NA0001_55_190_20160229_00162.jpg

03/16/2012 Wood privacy fence completely obstructs access and visibility.

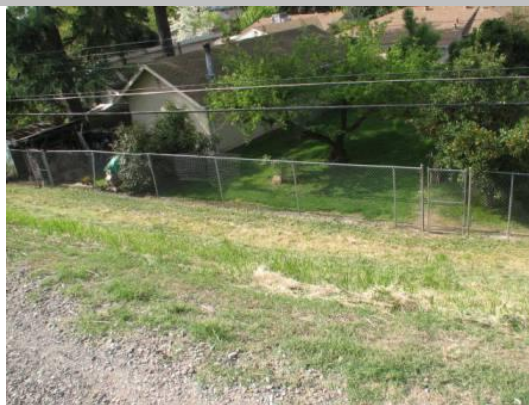
Photo 1 of 1 : SP_2016_NA0001_55_194_20160229_00165.jpg

04/14/2011 Planter boxes have been removed. Chainlink fence partially blocks access.

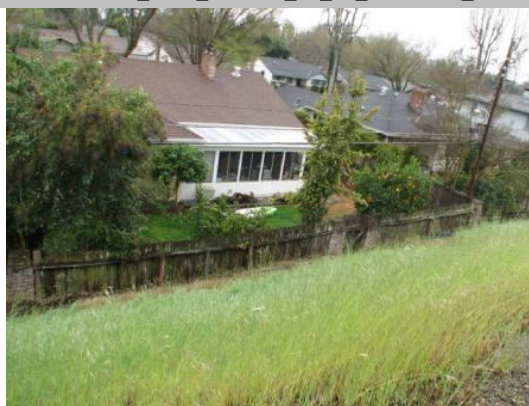
Photo 1 of 1 : SP_2016_NA0001_55_30_20160229_00030.jpg

03/16/2012 Wood privacy fence completely obstructs access and visibility.

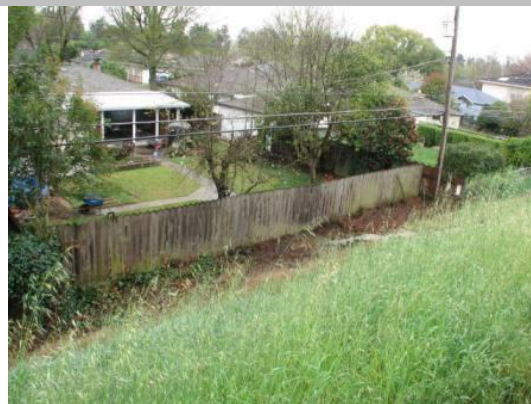
Photo 1 of 1 : SP_2016_NA0001_55_35_20160229_00032.jpg

03/16/2012 Wood privacy fence completely obstructs access and visibility.

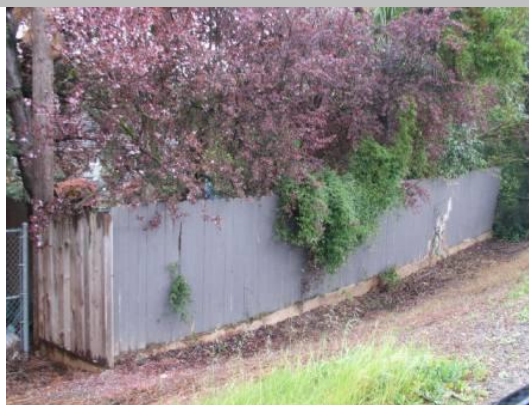
Photo 1 of 1 : SP_2016_NA0001_55_48_20160229_00039.jpg

03/16/2012 Wood privacy fence completely obstructs access and visibility.

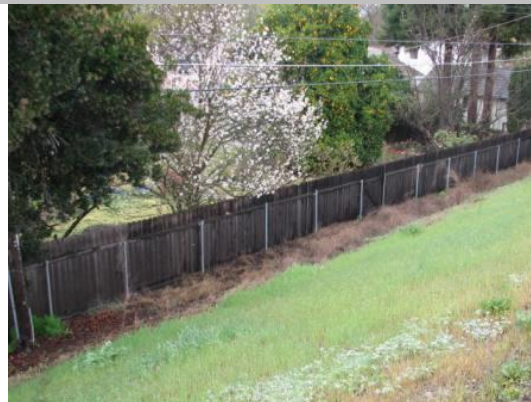
Photo 1 of 1 : SP_2016_NA0001_55_54_20160229_00044.jpg

03/16/2012 Wood privacy fence completely obstructs access and visibility.

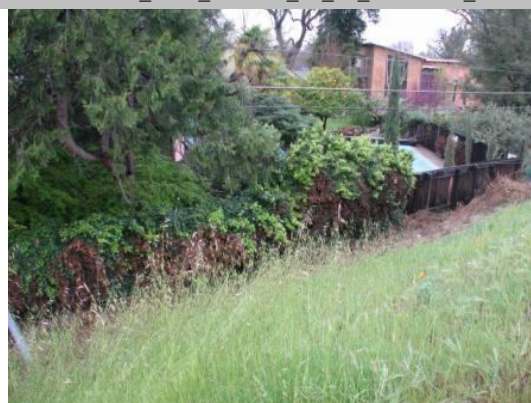
Photo 1 of 1 : SP_2016_NA0001_55_72_20160229_00056.jpg

03/16/2012 Wood privacy fence completely obstructs access and visibility.

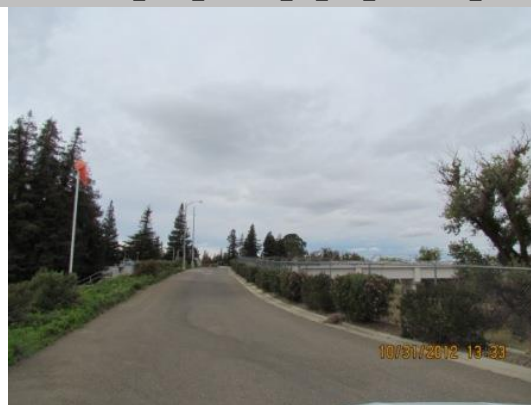
Photo 1 of 1 : SP_2016_NA0001_55_140_20160229_00119.jpg

View of landscaping at waterside hinge obstructing visibility.

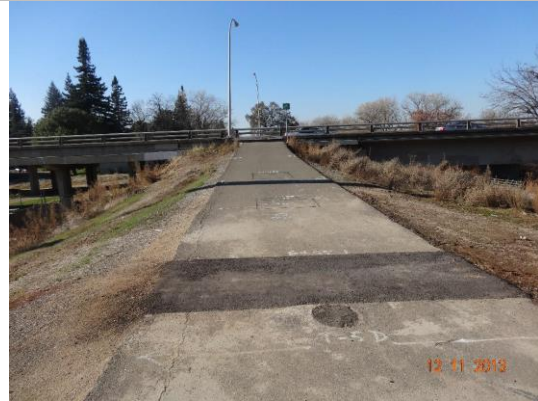
Photo 2 of 2 : UCIP_SP_2016_30023_55392.jpg

Signs of crossing repair patch section visible on levee crown.

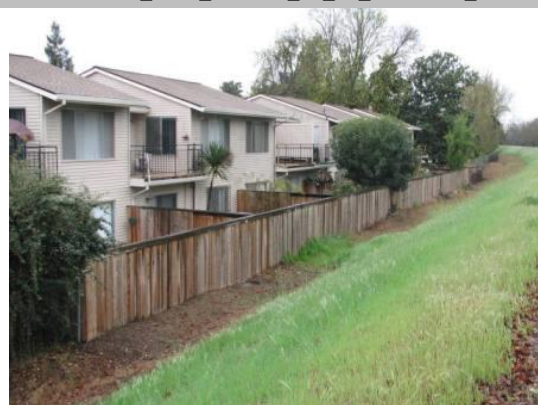
Photo 1 of 1 : SP_2016_NA0001_55_74_20160229_00058.jpg

03/16/2012 Wood privacy fence completely obstructs access and visibility.

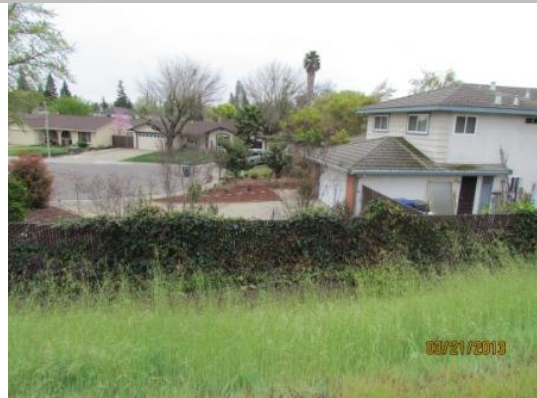
Photo 1 of 1 : SP_2016_NA0001_55_225_20160229_00178.jpg

View of the landscaping at the levee toe.

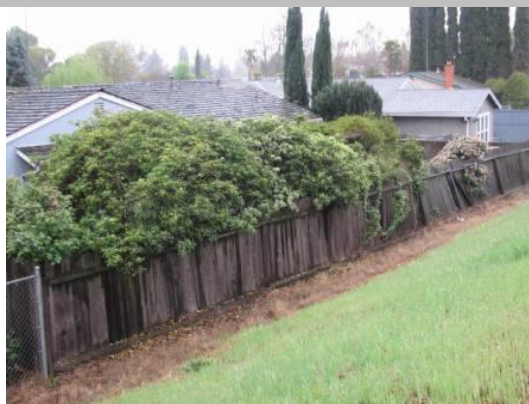
Photo 1 of 1 : SP_2016_NA0001_55_104_20160229_00088.jpg

03/16/2012 Wood privacy fence completely obstructs access and visibility.

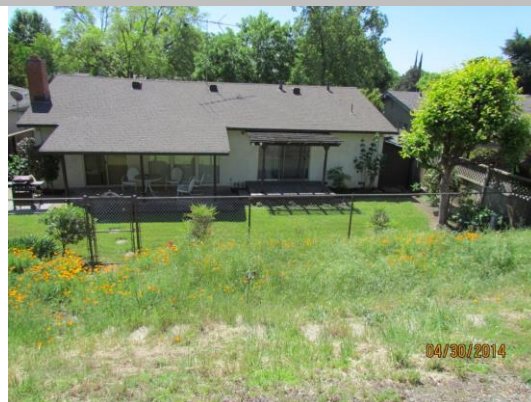
Photo 1 of 1 : SP_2016_NA0001_55_246_20160229_00189.jpg

View of the irrigation and retaining wall at the landside levee toe.

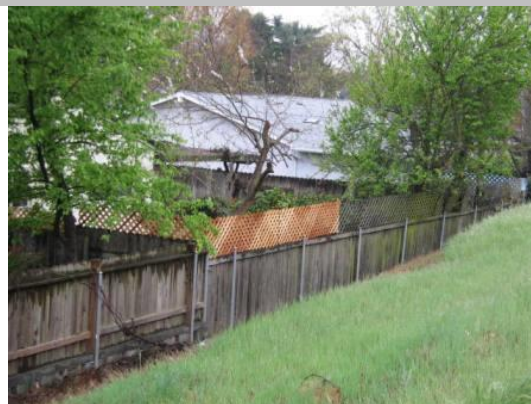
Photo 1 of 1 : SP_2016_NA0001_55_109_20160229_00093.jpg

03/16/2012 Wood privacy fence completely obstructs access and visibility.

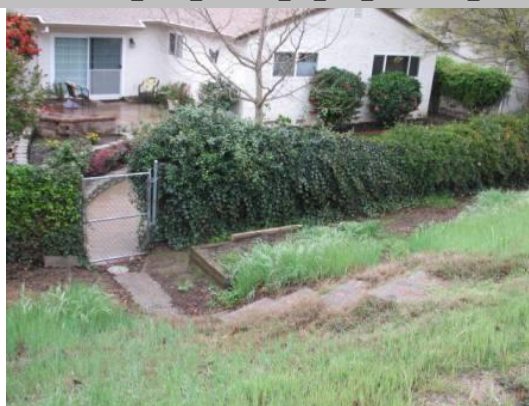
Photo 1 of 1 : SP_2016_NA0001_55_113_20160229_00097.jpg

03/16/2012 Landscaping on chainlink fence blocks visibility and access.

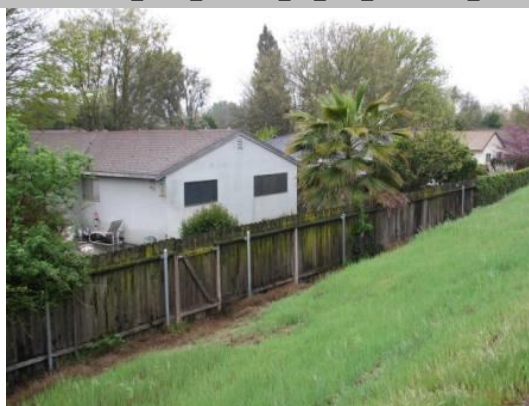
Photo 1 of 1 : SP_2016_NA0001_55_115_20160229_00099.jpg

03/16/2012 Wood privacy fence completely obstructs access and visibility.

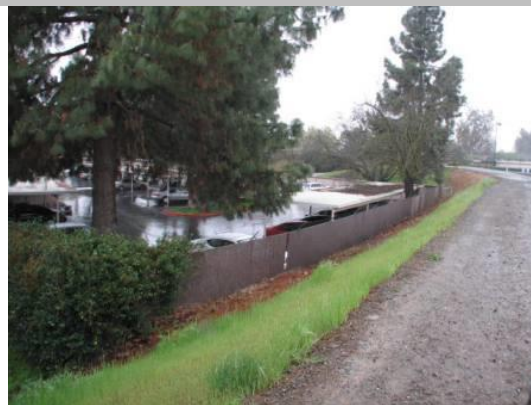
Photo 1 of 1 : SP_2016_NA0001_55_235_20160229_00182.jpg

03/16/2012 Chainlink fence with privacy slats and barbed wire obstruct visibility and access.

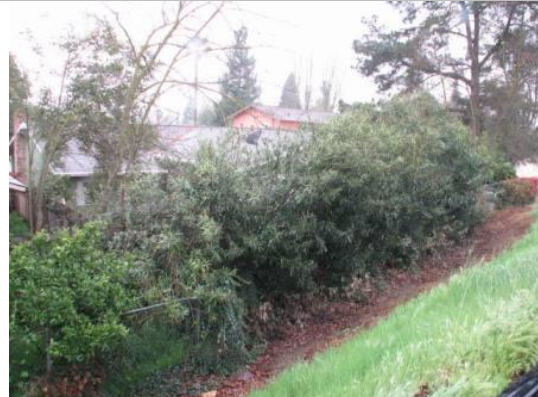
Photo 1 of 1 : SP_2016_NA0001_55_121_20160229_00104.jpg

03/16/2012 Landscaping obstructs visibility and access.

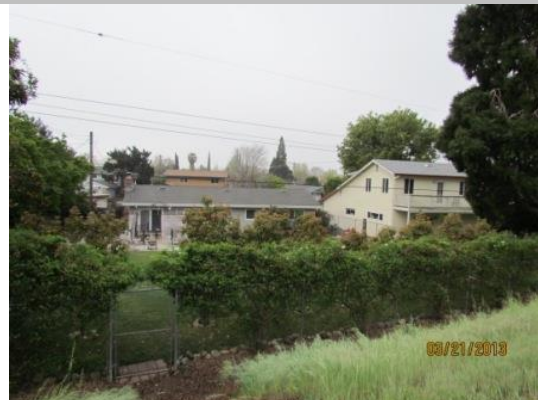
Photo 1 of 1 : SP_2016_NA0001_55_129_20160229_00110.jpg

View of landscaping at levee toe.

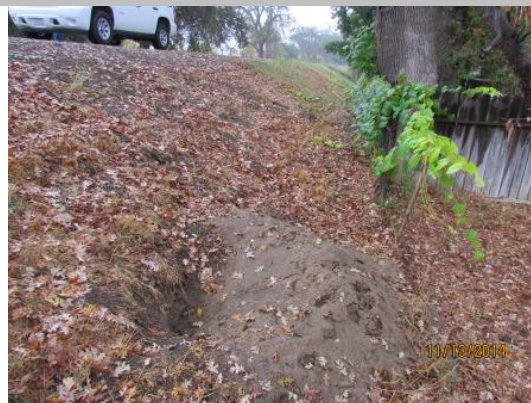
Photo 1 of 1 : SP_2016_NA0001_55_239_20160229_00185.jpg

View of several large rodent burrows.

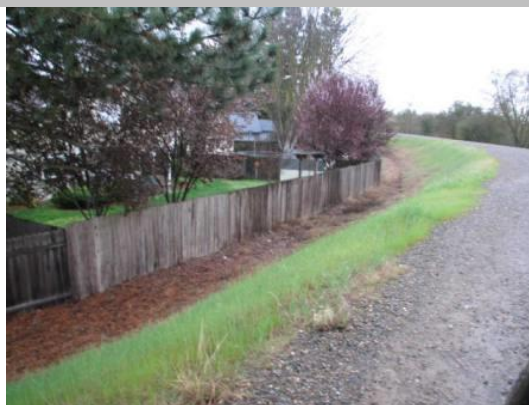
Photo 1 of 1 : SP_2016_NA0001_55_149_20160229_00128.jpg

03/16/2012 Wood privacy fence completely obstructs access and visibility.

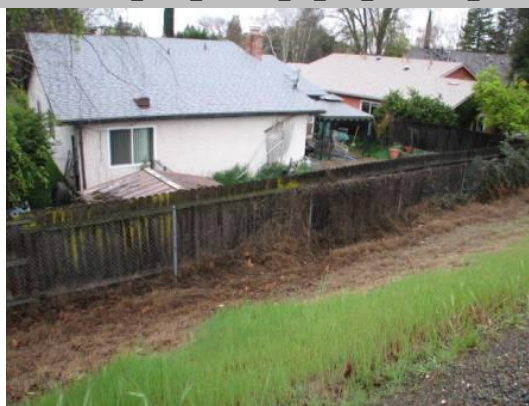
Photo 1 of 1 : SP_2016_NA0001_55_151_20160229_00130.jpg

03/16/2012 Wood privacy fence completely obstructs access and visibility.

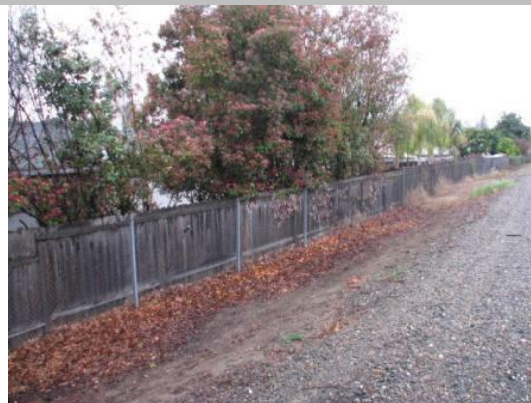
Photo 1 of 1 : SP_2016_NA0001_55_171_20160229_00149.jpg

03/16/2012 Wood privacy fence completely obstructs access and visibility.

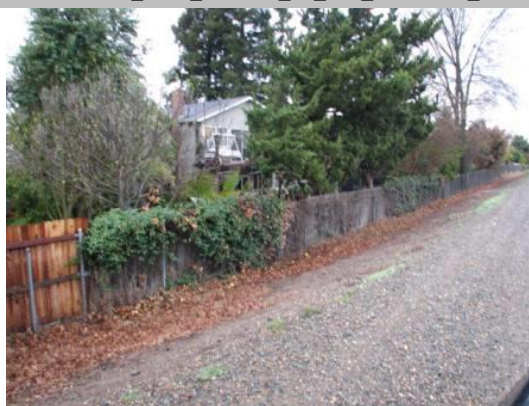
Photo 1 of 1 : SP_2016_NA0001_55_167_20160229_00145.jpg

03/16/2012 Wood privacy fence completely obstructs access and visibility.

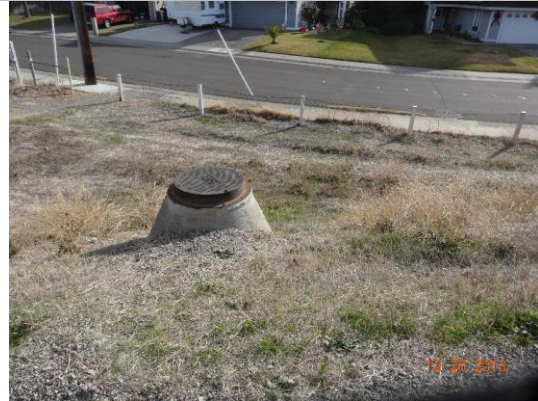
Photo 2 of 2 : UCIP_SP_2016_30706_56558.jpg

Manhole located on landward slope.

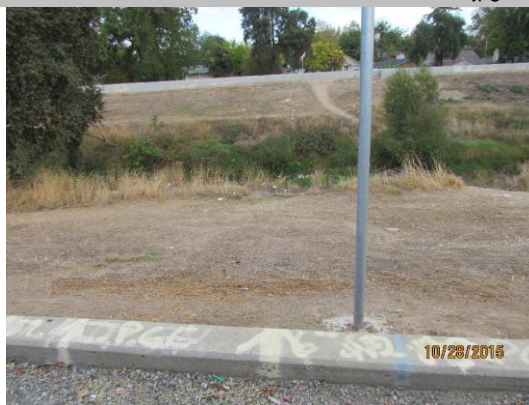
Photo 1 of 2 : UCIP_SP_2016_46795_74733.jpg

Markers installed through both levees in 2015.

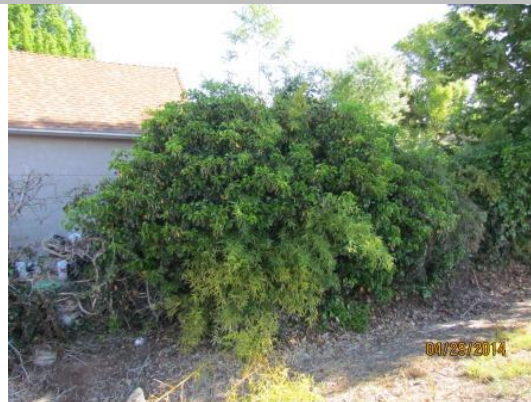
Photo 1 of 1 : SP_2016_NA0001_58_10_20160229_00008.jpg

Landscaping has grown over the fence and obstructs visibility and access.

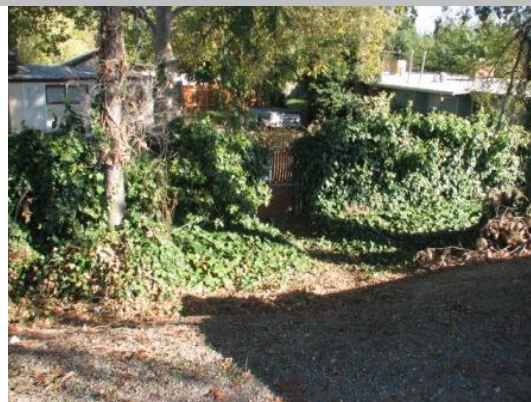
Photo 2 of 2 : SP_2016_NA0001_58_15_20160229_00014.jpg

Fall 2009 photo of dense ivy and fence obstruct visibility and access.

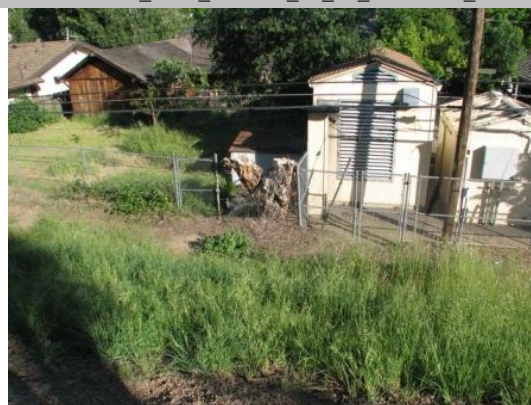
Photo 1 of 1 : SP_2016_NA0001_60_14_20160229_00005.jpg

Tree trunk at fence line.

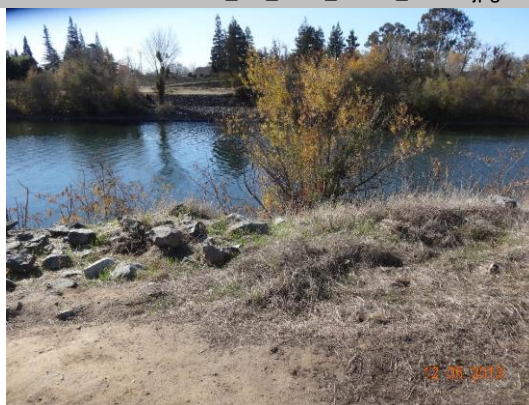
Photo 2 of 2 : UCIP_SP_2016_46085_54712.jpg

View of waterward edge--rip rap used to armor toe.

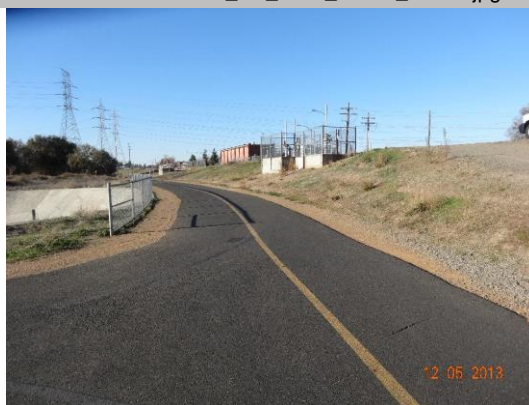
Photo 2 of 2 : UCIP_SP_2016_31304_57320.jpg

Bike path located on waterward side.

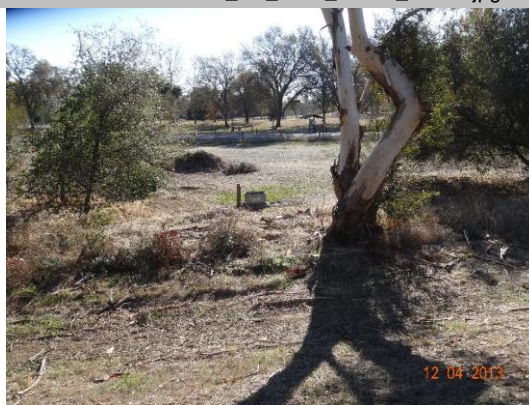
Photo 2 of 2 : UCIP_SP_2016_26281_47493.jpg

View of faucet located on waterward side.

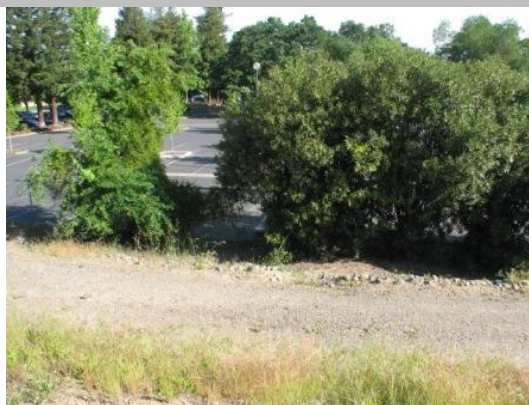
Photo 1 of 1 : SP_2016_NA0001_61_6_20160229_00002.jpg

Trees at fence line obstruct access and visibility.

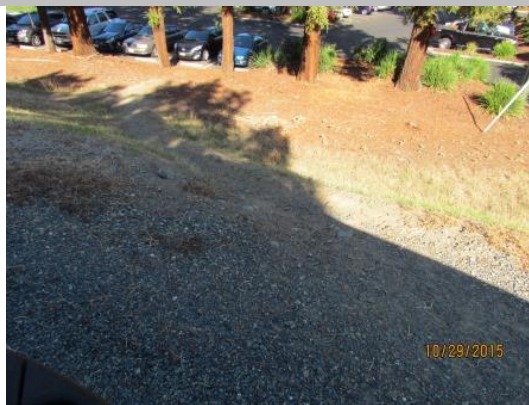
Photo 1 of 1 : SP_2016_NA0001_61_21_20160229_00005.jpg

View of the footpath on the landside levee slope.

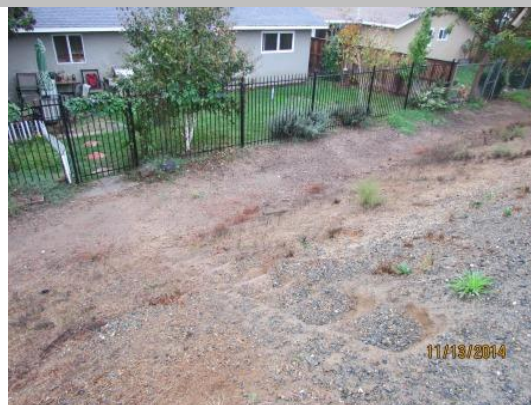
Photo 1 of 1 : SP_2016_NA0001_438_1_20160229_00001.jpg

View of the stairs on the landside levee slope.

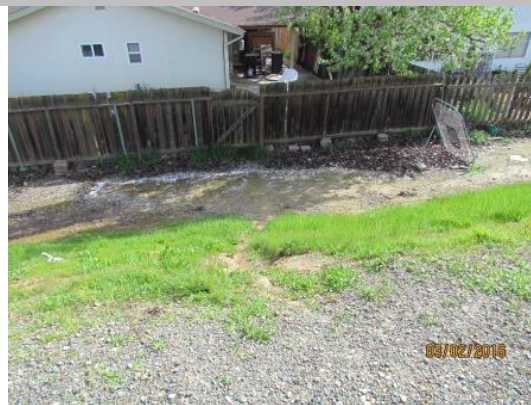
Photo 1 of 1 : SP_2016_NA0001_438_4_20160308_00013.jpg

View of the footpath on the landside levee slope.
